Appendix J

Aquatic Plant and Water Depth Survey -- August 8, 2006

Notes from August 8, 2006 Aquatic Plant/Water Depth Survey on Nagawicka Lake

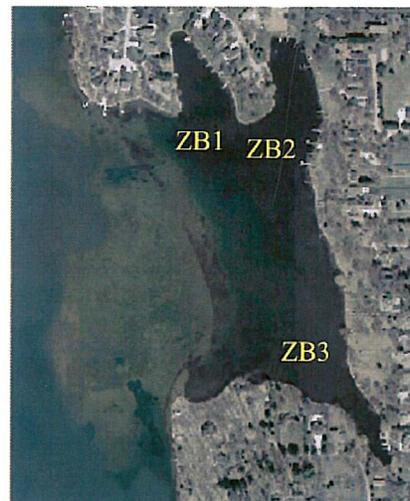
Site #1 – ZB1 - Zastrow's Bay (west)

- 3.25' to 3.5' water depths in channel – shallower water seen within pier reach of shoreline
- Very clear water
- Lots of small northern pike found in the area in fall

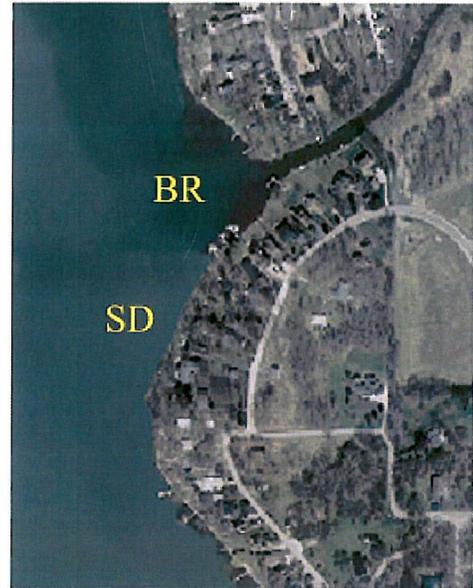
Site #4 – BR - Bark River Inlet

- Variable water depths
- Very deep sediment; > 4'
- Aquatic vegetation laden with fine floccular sediment
- Sparse plant growth
- OK to dredge – Heidi’s comment

Restoration Limits – Heidi commented that vegetation restoration in this area would not be successful

- ❖ Too much boat traffic
- ❖ Too much silt entering area

EWM eradication/control not feasible for the inlet area.

- Too much area to cover for liquid herbicide & granular herbicide applications
- Too much inflow of water from Bark River
- Too much boat traffic

Weevils may be the best option. They do have a population cycle that ranges from 5-9 yrs.

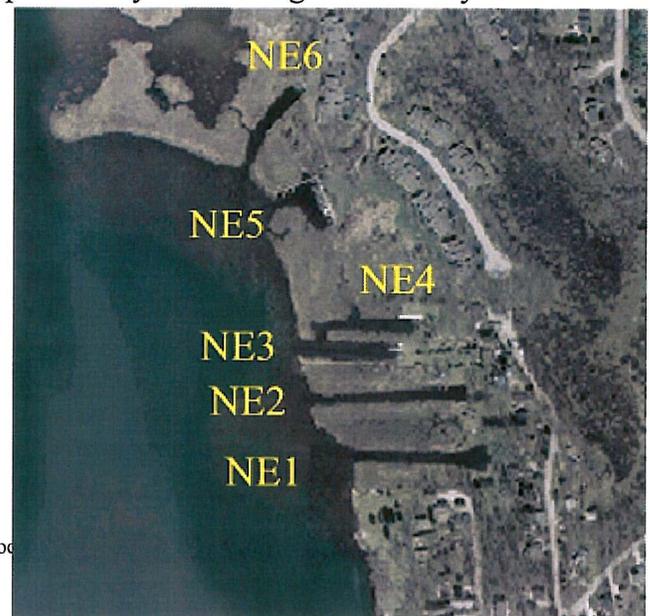
Site #5 – NE (1-6) - Northeast Channels

1) Very shallow; 2' water depth at center of channel. Lisa recommend 5' of undredged 'buffer' along shorelines be left untouched to ensure shoreline stability. Lisa also recommended anchoring woody tree falls diagonally along the shoreline in natural areas. In developed areas of the channel, 16" diameter biolog would be a great alternative to the existing sea walls.

2) Also shallow in middle of channel. Same vegetation as above seen with swamp willow being very prevalent. Anchored tree falls are also recommended for this channel.

3) Very narrow channel. Shallow in middle. No tree falls recommended due to narrowness of channel.

4) Heidi called this area 'Very Special Habitat'. Lots of tamarack. Very shallow depths – we did not go down this channel. Heidi felt dredging was not an option – the stability of the shorelines could not be risked.

5) Good water depths – heavy development on the channel. Aerators used along piers. (No tree falls recommended).

6) Good water depths – lots of fern vegetation on the shorelines. (No tree falls recommended).

Heidi asked Lisa if utilizing biolog along the shorelines would help keep the shorelines stabile. Lisa commented that the biolog will degrade over a period of 5 to 7 years & that its purpose is generally to absorb wave, ice, & other erosive factors while vegetation is allowed to recover on a sensitive shoreline area. Since these shorelines are already well vegetated with soft and woody vegetation, the biolog would only really act to retain the very top of the sediment & that it would

be possible that the sediment could be pulled out from under the biologs if dredging was at a steep angle too close to the shoreline areas. This soft sediment & uncompacted shoreline soil would make anchoring the biologs quite difficult as well.

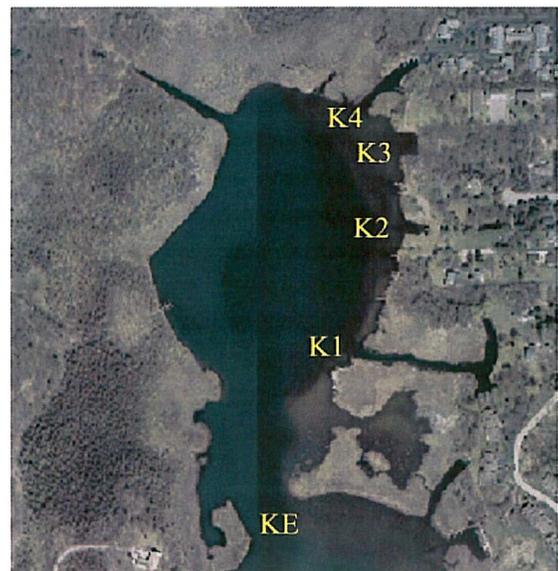
Site #6 – KE & K (1-4) - Kettle

K1 – 3' water depths (only one spot under 3'). Too narrow for tree falls.

K2 – 3' water depths. Heidi recommended that owner extend pier to deeper water – 3' water depth. Too much native aquatic vegetation to get to the end of the channel. Lots of young of the year bass seen.

K3 – Lots of water lilies. Heidi said dredging not favored there; owner should extend pier to 3' water depth.

K4 – 3' to 4' water depths. Heidi felt dredging not necessary. A few spots at mouth of channel showed depths just under 3'. Large parallel pier along much of north shoreline. Elevated pier along south shoreline. Lots of mowed lawn along water. Fifteen+ slips in the channel. Heidi commented that it exceeded reasonable use for the area. {DNR regs state that, in general, riparian landowners get 2 slips for the first 50' they own & 1 slip for each 50' after that.}

KE - Heidi strongly recommended creating a specific, marked navigation channel into and out of the channel. This would assist in keeping the depth greater than 3' by not stirring up the shallower water/sediment along the west side of the Kettle entrance. It appears that over time, the entrance may have shifted eastward as sediment accumulated along the west side of the entrance.

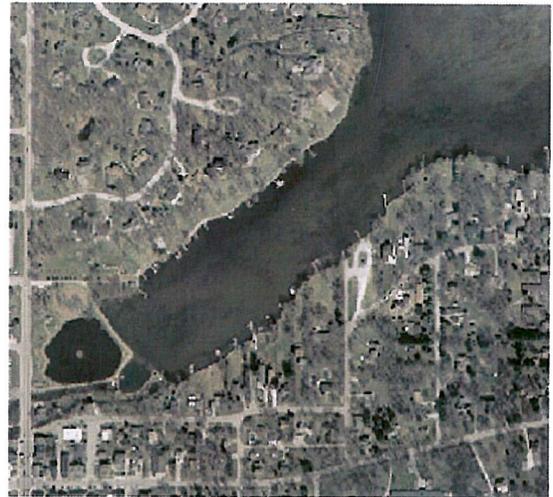
Site #7 - St. John's Bay

- o Water depths 3.25' to 3.5'
- o Only a couple spots less than 3' deep at or within the pier head line along southern shoreline
- o No milfoil seen
- o Very healthy celery, clasping leaf pondweed, IL pondweed, naiad, and sago pondweed communities seen – excellent/exceptional habitat
- o Very clear water seen (except where aquatic plant harvester had recently cut/scraped bottom)
- o Heidi commented (but we did not visit) shallow area (approx. 200') along west shore where main lake curves into St. John's Bay would be OK to dredge
- o St. John's Bay heavily used by migratory waterfowl
- o Sue commented that the fishery in the bay was outstanding; many forage species known to be there, specifically the chub sucker

Jerry commented that sheriff's boat needed safe/rapid entry/exit of bay for emergency response. Heidi questioned the issue since water depths are generally greater than 3.5' in channel.

Jerry commented that depth problem inevitable; dredging would be more of a proactive move on the part of the city.

Sue commented that if the bay is silting in that rapidly (1' in ten years), watershed issues must be addressed first. She also commented that as it is, St. John's Bay fisheries habitat couldn't be improved upon – it is that good.

Heidi & Sue commented that those few landowners dealing with less than 3' water depths along their piers should extend the piers to the 3' water depth. This would not impact navigation.
